DEFENCE AND CIVIL INSTITUTE
OF ENVIRONMENTAL MEDICINE

November 1984

DCIEM NO. 84-C-46

DYNAMIC TESTING OF THE CT114
TUTOR EJECTION SEAT

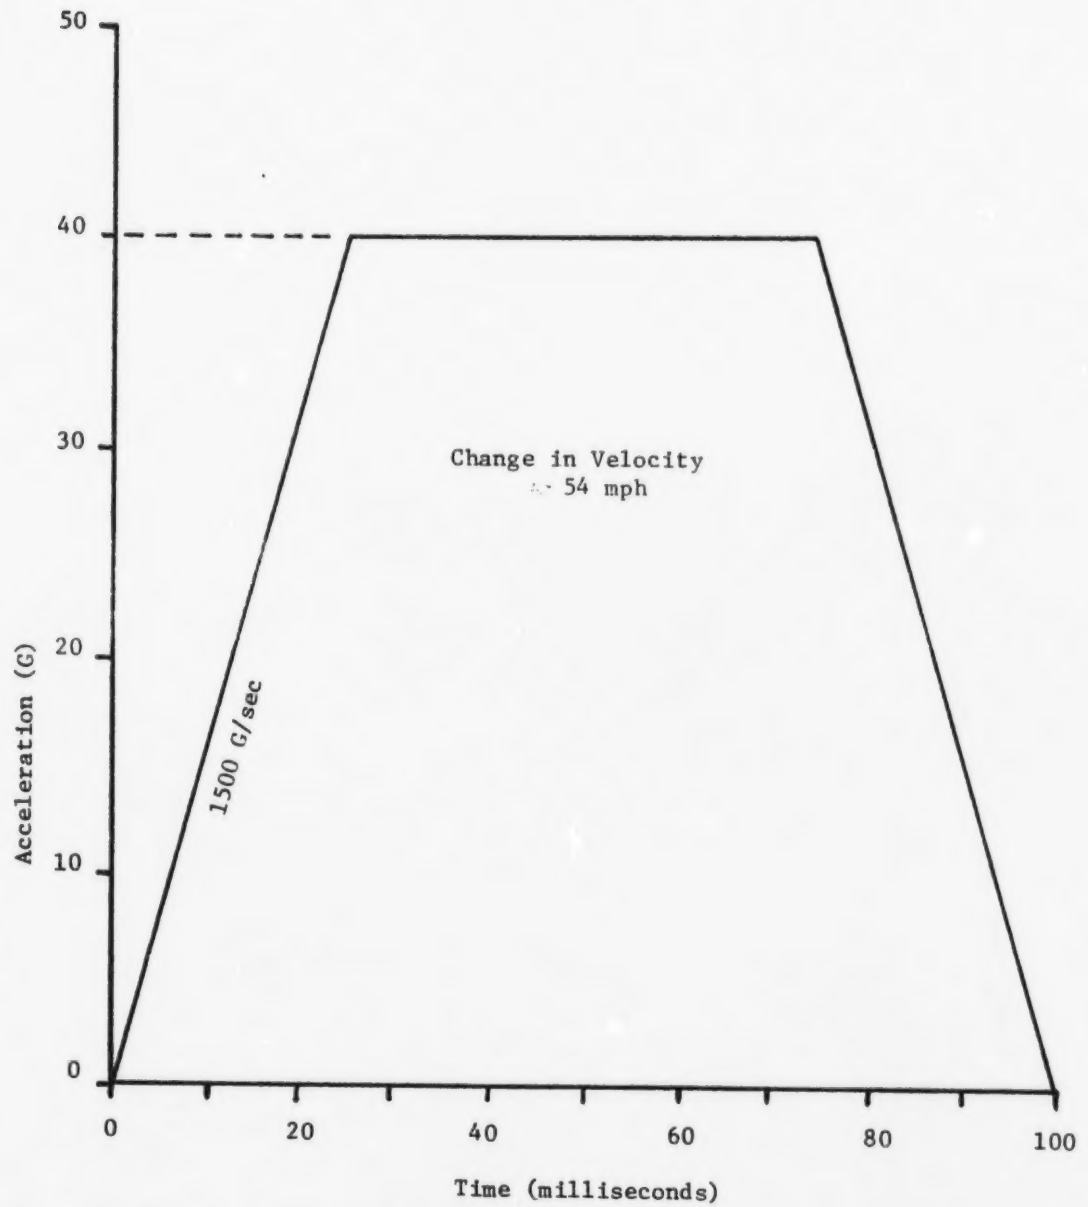
Figure 2: Recommended Longitudinal Design Crash Pulse as per MIL-S-18471F(AS)

The two most recent and relevant U.S. military specifications for ejection seats require dynamic testing at a peak acceleration level of 40 G's for frontal and $\pm 20^\circ$ impacts, resulting in a change in velocity of 54 MPH, as shown in Figure 2 (6,7). However, since the CT114 seat had not originally been designed to meet this particularly demanding specification, the decision was made to retain the peak acceleration requirement at 40 G's, but to reduce the velocity change from 54 MPH to one that would produce a 40 G deceleration in a typical longitudinal impact. The data from the Crash Survival Design Guides (3,4) were consulted for this purpose, and it was found that a 40 G longitudinal impact deceleration corresponds to a 97% CFO value, which, in turn, requires a velocity change of 36 MPH. Consequently, this was the targeted velocity change for all the impacts in the test program.

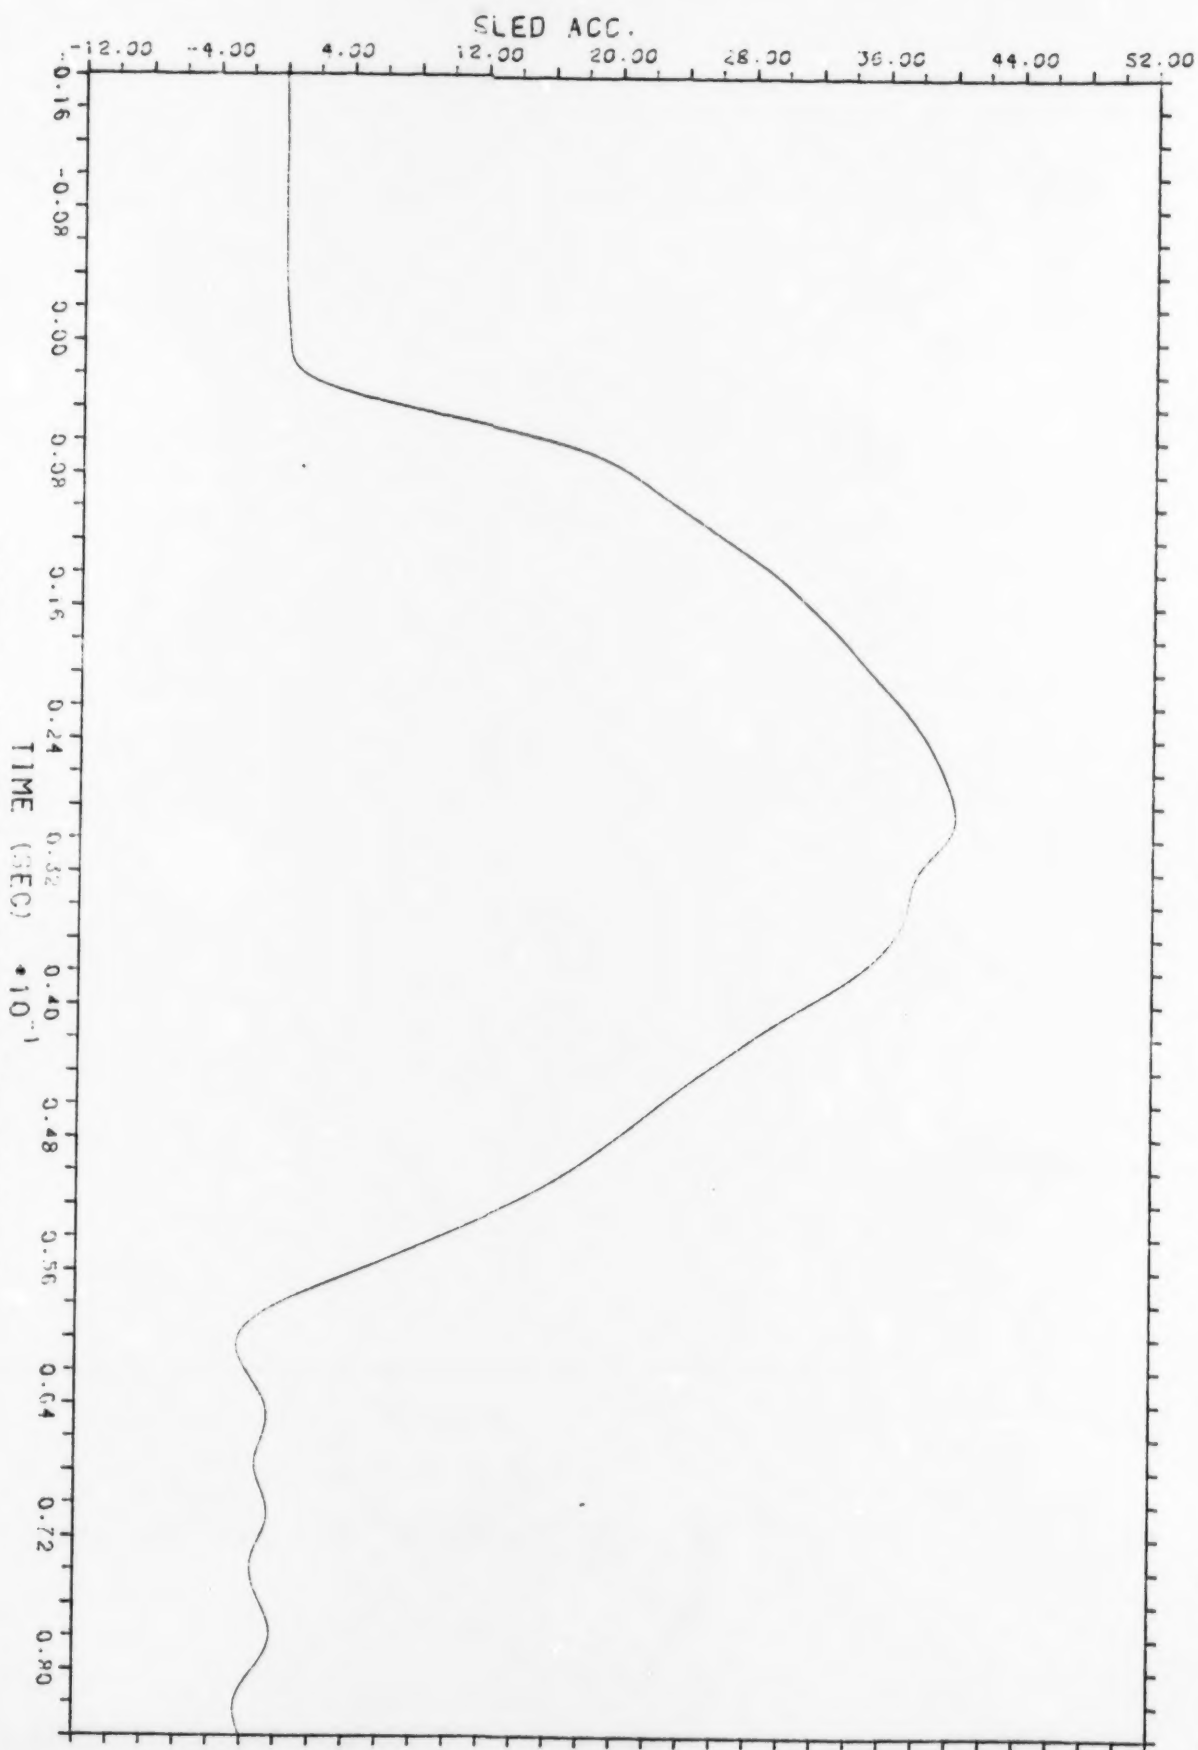
Figure 3. Simulated Crash Pulse Used for All Test Runs

Concerning the precise pulse shape, a one-half sinusoid-shaped acceleration profile was used for this test series, following the practice established for the previous AETE test programs. An example of this profile, from run #510, is shown in Figure 3, and is very similar in shape to the triangular-shaped profile recommended in the Crash Survival Design Guides (3,4).
